**EVALUATION OF TREES AT THE
SOUTHBAY CHRISTIAN CENTER
539 E. WEDDELL DRIVE
SUNNYVALE**

**Prepared at the request of:
Brian Pendley
Pendley & Associates
9008 Siegal Street
Valley Springs, CA 95252**

**Prepared by:
Michael L. Bench
Consulting Arborist
August 4th, 2005**

Job # 08-05-157 Site II

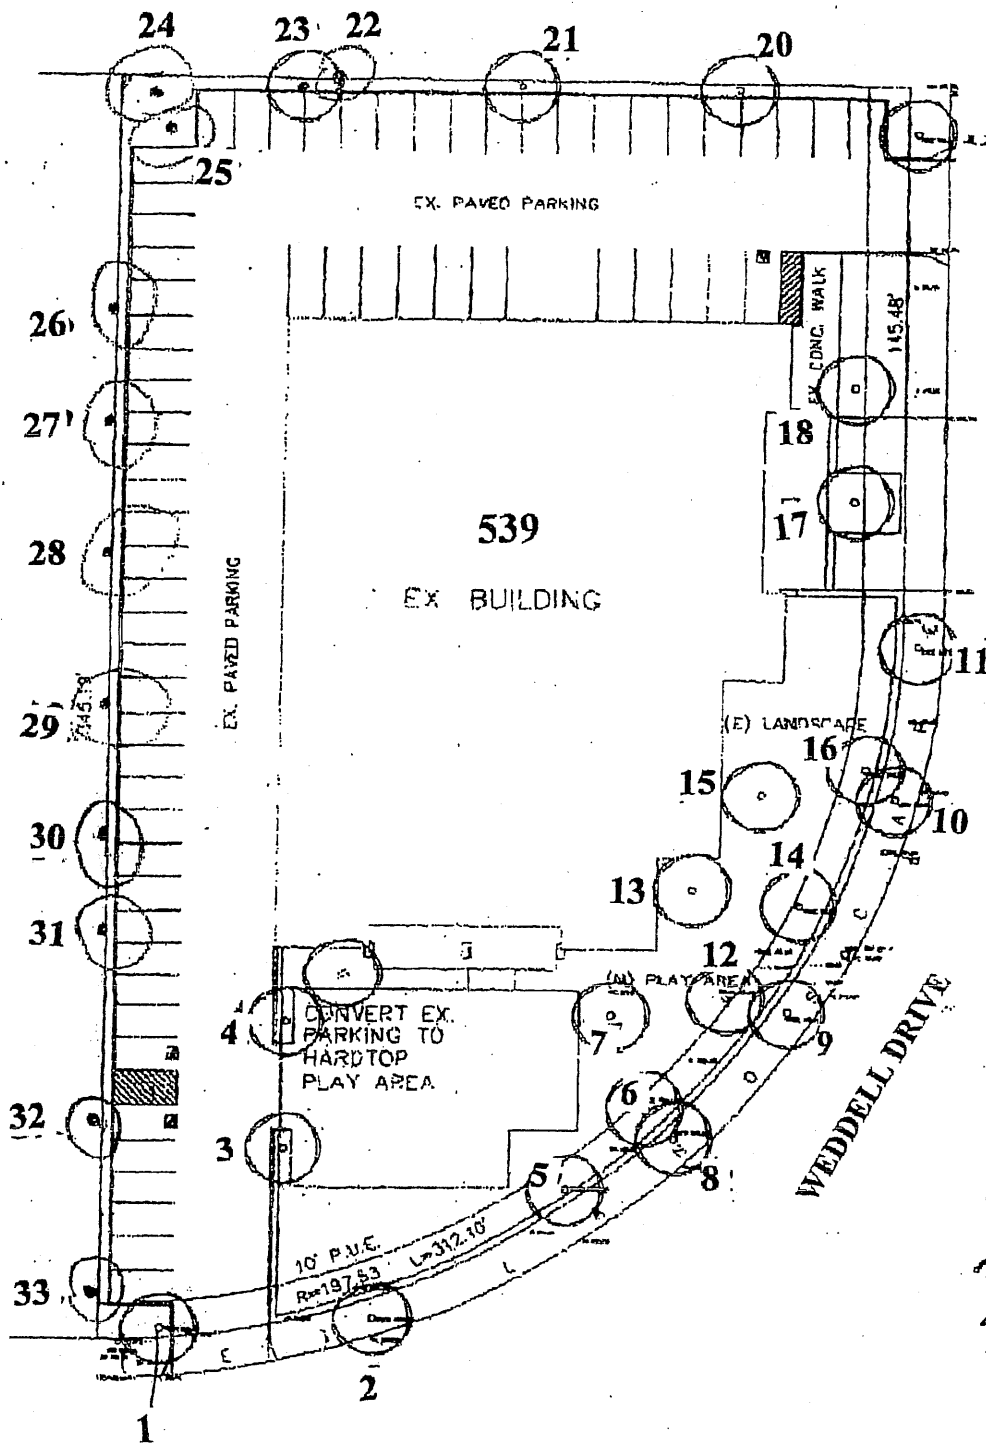
Tree numbers correspond to evaluation charts.
All dimensions and tree locations are
approximate.
